# Manhole makeover

Engineering solutions for a successful renewal program

BY JOHN JURGENS

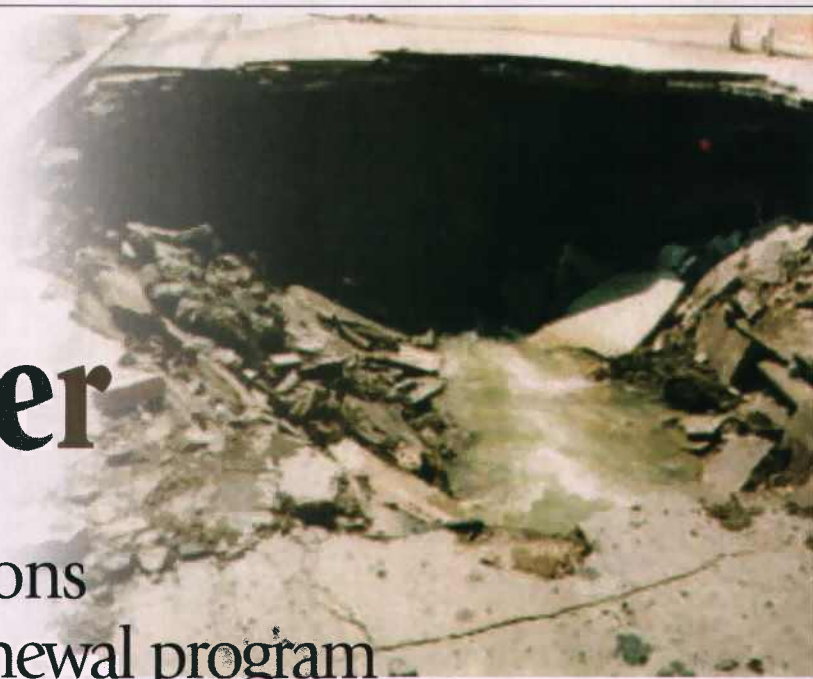
**When neglected, erosion from groundwater intrusion, corrosion from liquids and gases, and wear from dynamic traffic loads can lead to complete collapse of a manhole.**

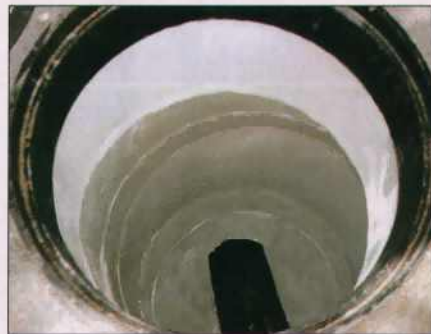
**In corrosive environments, a manhole can be replaced without digging by installing a plastic liner fitted to a form, and filling the annulus space between the form and the old wall with concrete.**

Two, less expensive options are no-dig and partial-dig solutions. No-dig methods use forms, which can be passed through existing openings and assembled entirely within the old manhole. An annulus space between the forms and the old wall is filled with standard, department of transportation-specification ready-mixed concrete and vibrated into place creating a new, joint-free wall about 3 inches thick. In corrosive environments, a plastic liner with interlocking protrusions is fitted onto the form before placement of the concrete so that when the forms are removed, a fully plastic-lined concrete manhole remains in place.
